TECHNICAL MEMORANDUMS
NATIONAL ADVISORY COMMITTEE FOR AERONAUTICS

No. 443

DURALUMIN - DEFECTS AND FAILURES
By Lieut. Comdr. Wm. Nelson (CC), U.S.N.
From "Aviation," August 29, 1927

Washington
December 1927

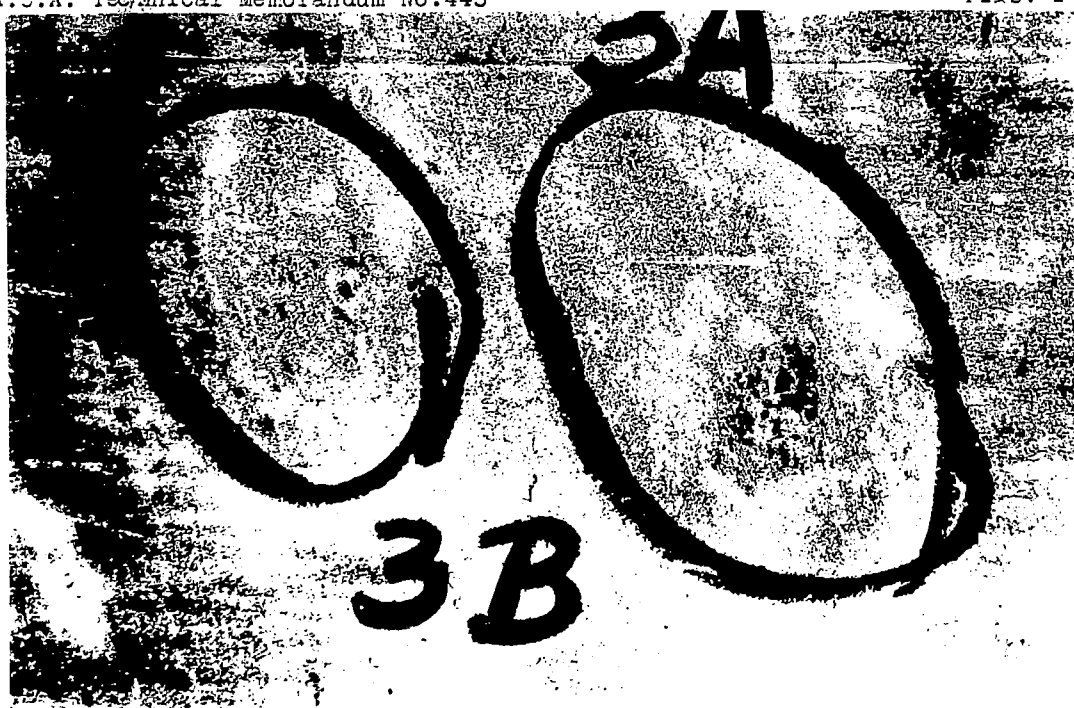
Fig.1 Inclusions in a duralumin sheet. Photograph is slightly magnified

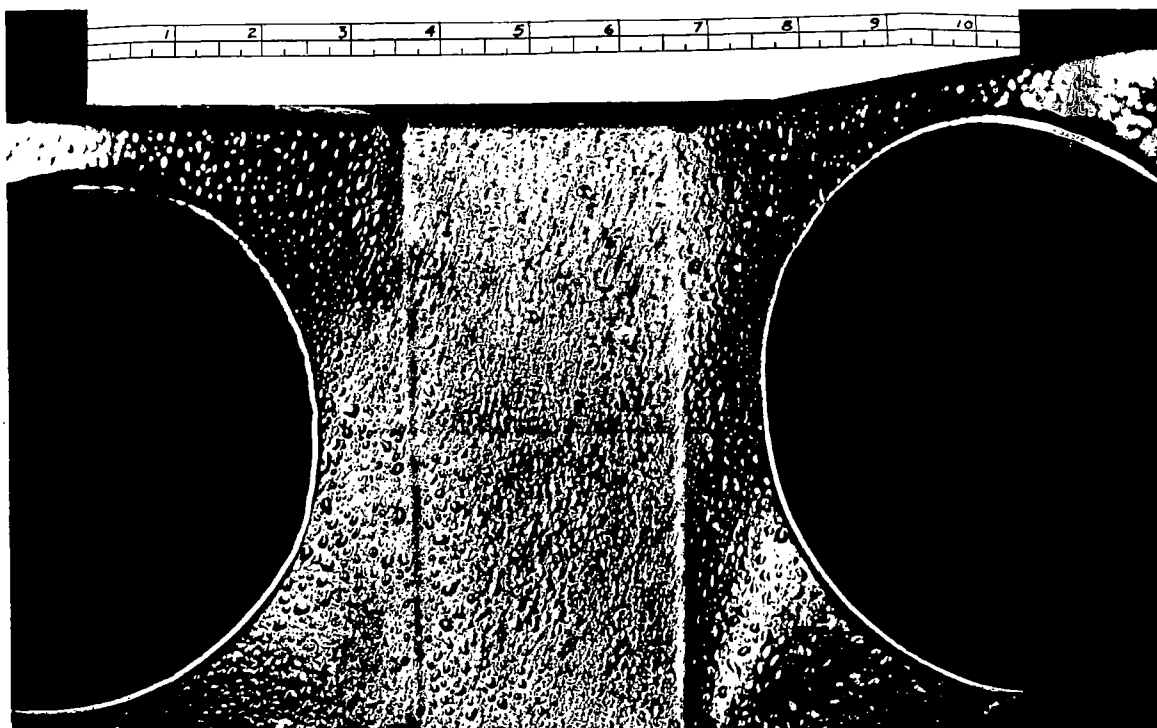
On the other hand, if duralumin is heated to a temperature near 540°C , there is apparently a change in the constitution

of the constituents indicating very strongly the beginning of the melting. This change according to the theory expressed may be accompanied by the formation of melting blisters which in themselves may not be harmful, but they do point out changed physical properties. The usual result of overheating is a perceptible drop in the elongation.

It is not practicable to distinguish between the two kinds of blisters by a visual inspection, so in case an abnormal amount of blistering is occurring it is best to suspect the temperature of heat treatment and if that is correct it is a matter for the makers of the raw material. It is not to the best interests of duralumin to lower the heat treating temperature to reduce blistering effect.

Fig.2 Duralumin blistered by overheating in heat treatment 62910 A S
